# BGA Shoulder Bolt Inspection

The primary goal of the inspection is to verify that the P6 BGA shoulder bolts are present (or backing out) in the locations which are readily visible during the MISSE and FPP photography tasks.

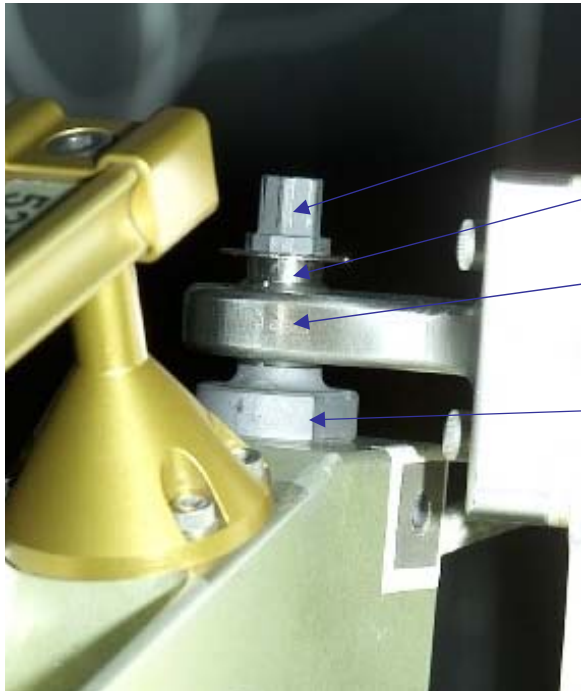
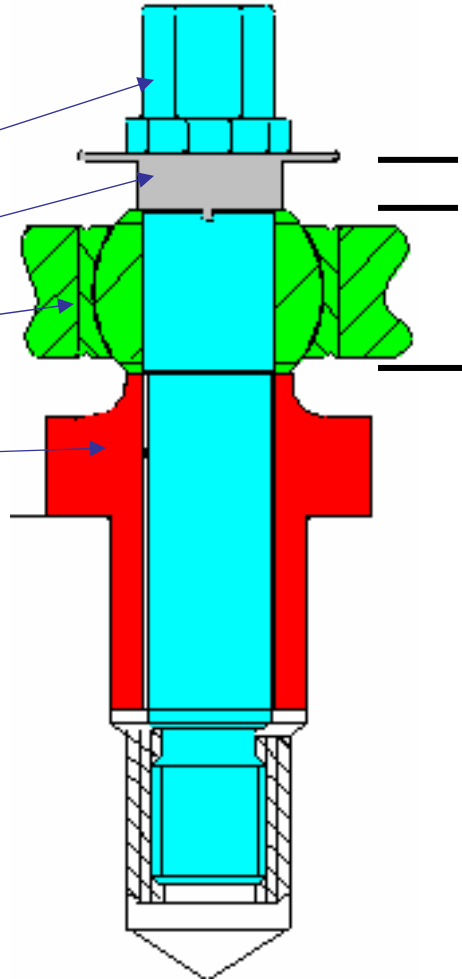
### Shoulder Bolt Assembly Cross-Section

A loose shoulder bolt would create gapping at any one (or all) of these three locations.
